Specification

New Court, Trinity College, Cambridge

The refurbishment of New Court at Trinity College, Cambridge, by 5th Studio and Max Fordham set out to radically improve the comfort and carbon emissions of a Grade I listed building. Five years after its completion, 5th Studio director Oliver Smith assesses the lessons that have been learnt

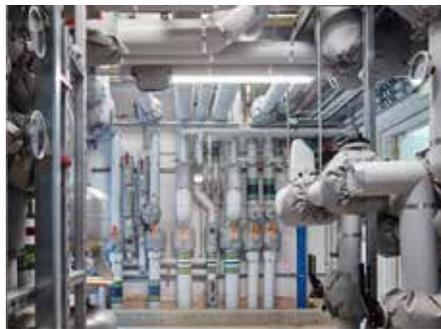
Left: A centralised plantroom efficiently provides heat and hot water and includes connections to the planned ground source heat pump.

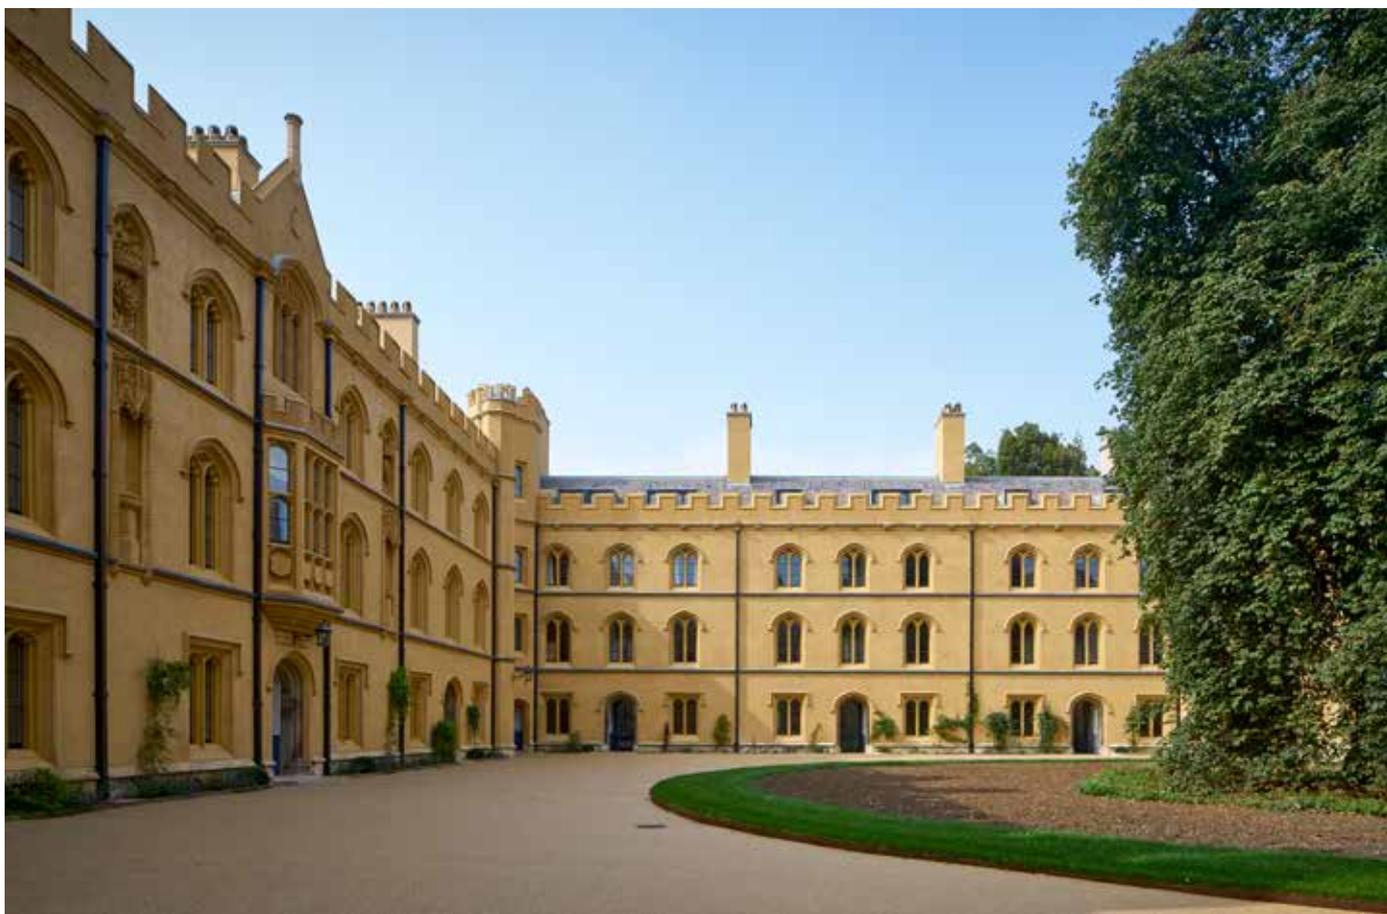
Opposite: Originally rendered with Roman cement, the courtyard-facing facades have been re-rendered using a permeable hydraulic lime painted with limewash.

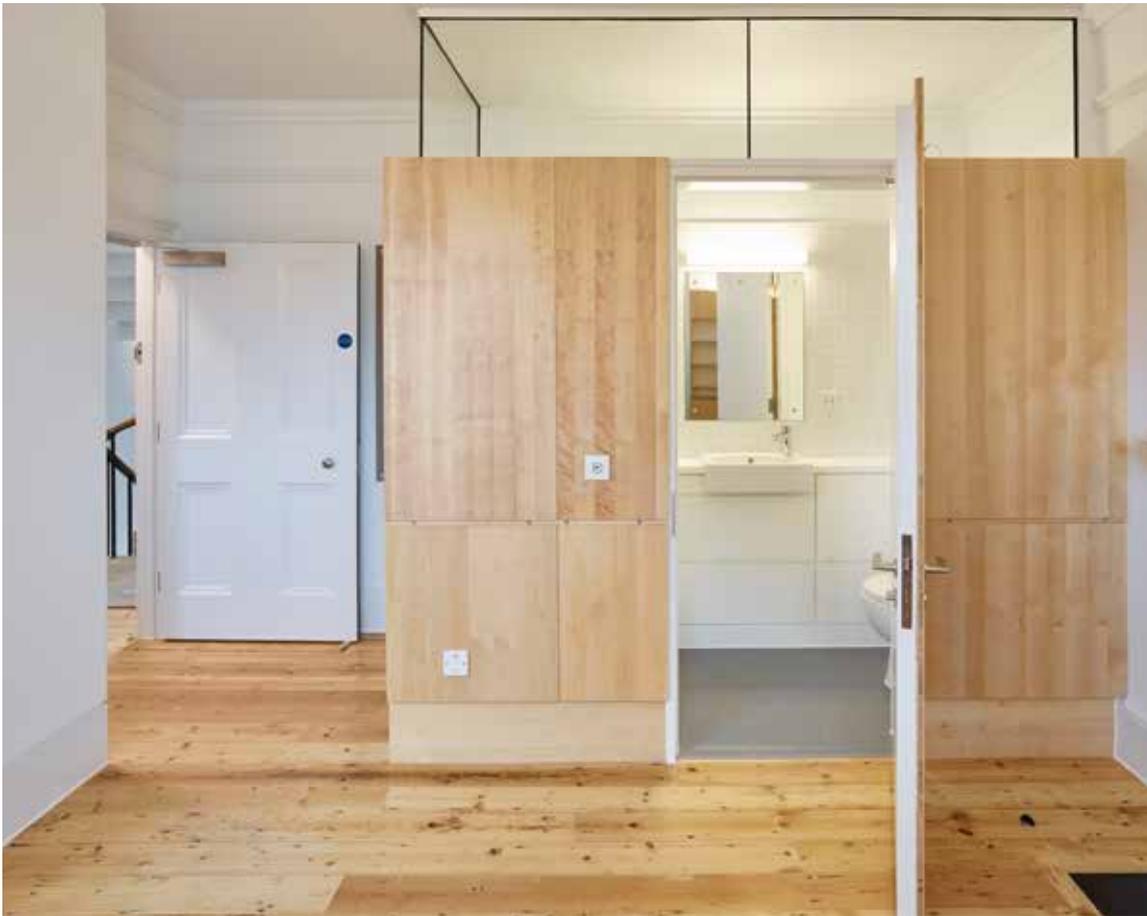
En-suites inserted into the existing floor plate bring 21st century amenity to a Grade I listed building. In order to avoid adding to the moisture load, shower rooms have been positioned away from external walls.

Extensive modelling suggested that it would be preferable to line the walls with a plastered 60mm-thick vapour-permeable Pavatex fireboard insulation system to give a U-value of $0.25\text{W/m}^2/\text{°C}$ and to do without a vapour barrier entirely, reducing heat loss while still allowing vapour movement through the insulation. Shower rooms – areas of high moisture generation – have been positioned away from external walls to avoid adding to the moisture load.

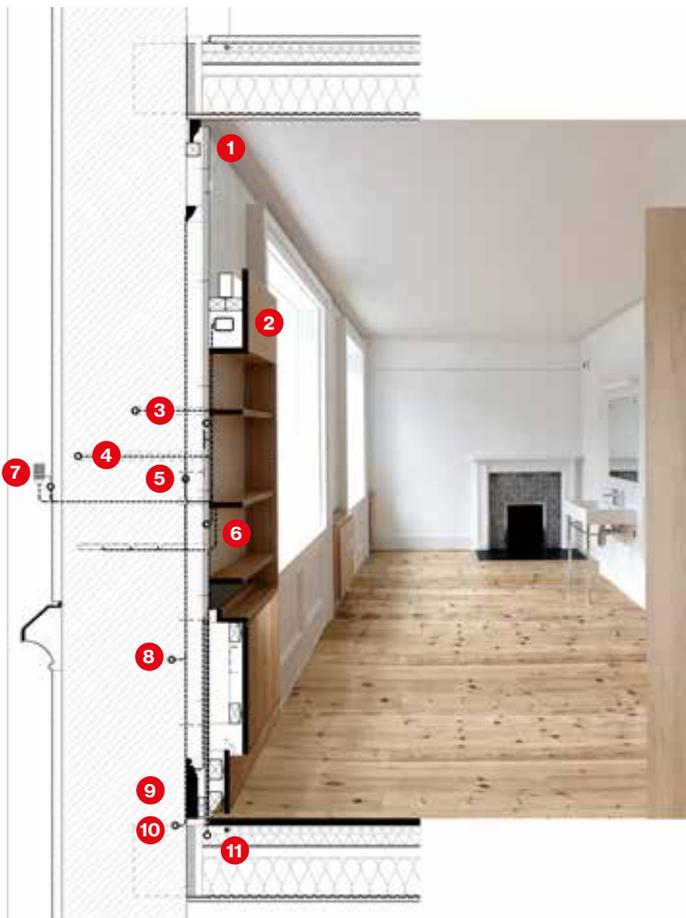
Position of sensors

Section/view of refurbished study bedroom showing sensors installed to measure moisture, relative humidity (RH), temperature and CO₂

- 1 Material condition monitoring (MCM) of cornice
- 2 Internal temperature, RH and CO₂
- 3, 4, 5, 6 Interstitial hydrothermal gradient monitoring
- 7 External temperature, relative humidity and solar radiation monitoring
- 8 MCM of wall
- 9 MCM of skirting
- 10 MCM of joists
- 11 Temperature and RH in floor voids

we led a programme of investigation, monitoring and modelling to gain a thorough understanding of the building's environmental performance, including in-situ U-value measurements, hygrothermal gradient monitoring, airtightness and thermal imaging, air pressure testing, and on-site weather data collection. At this early stage, this was as much a research project as it was a traditional building project, and the College established a technical committee to scrutinise the methodology, outcomes and technical proposals that emerged.

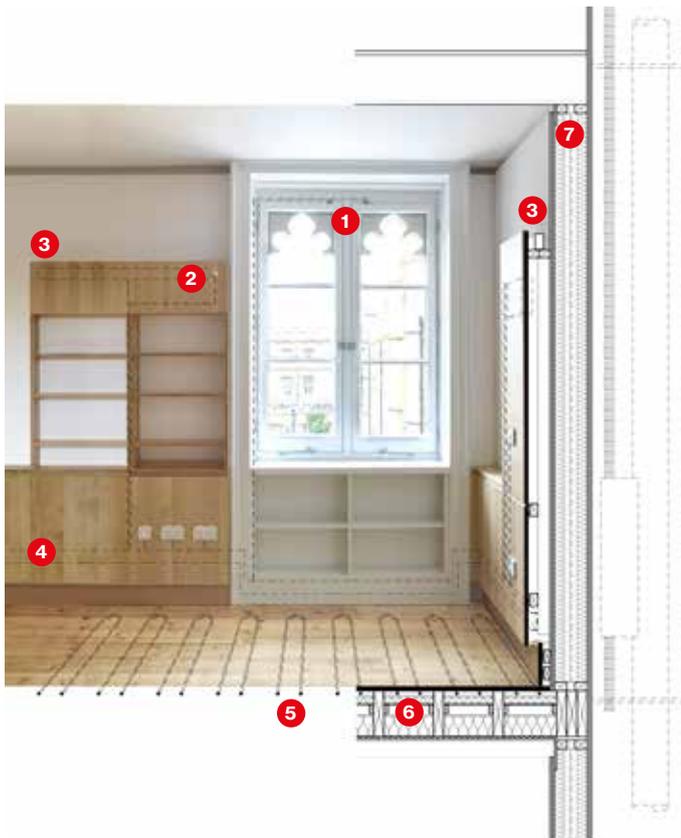
Interior retrofit

Section/view of refurbished study bedroom showing strategy to upgrade thermal performance and reduce heating load

- 1 Contacts (heating is turned off if window is opened)
- 2 Absence detector
- 3 Uplighters
- 4 Three-component trunking
- 5 Underfloor heating pipes
- 6 Acoustic insulation
- 7 Insulation to outside wall

Services are concealed in wooden panels that also incorporate uplighters

indicated that this would have minimal impact on heat loss or on the creation of cold bridges and condensation risk – resulting in what was accepted as an 'honest' retrofit approach where the addition of a new lining to a historic shell defines the character of the room. The contemporary character – and warmth is expressed by bespoke timber fittings designed by 5th Studio, including bookcases, storage units and wall panels that conceal services, eliminating the need to chase cabling into walls.

The archaic central heating system was replaced with underfloor heating installed beneath the original Georgian floorboards and to be warmed by ground source heat pumps. Rooms are generally maintained at 21°C, but occupancy sensors keep energy consumption to a minimum. The temperature is automatically reduced if a room is unoccupied for more than two days. Sensors in the window frames also ensure that the heating is turned down when the window is open for any length of time during the heating season.
